**Subdivision  
of  
Lot 502 Brand Highway, Dongara**

**GUIDELINES FOR BUILDING**

*Civil Technology  
17 Lyall Street  
South Perth WA 6151*

**December 2007**

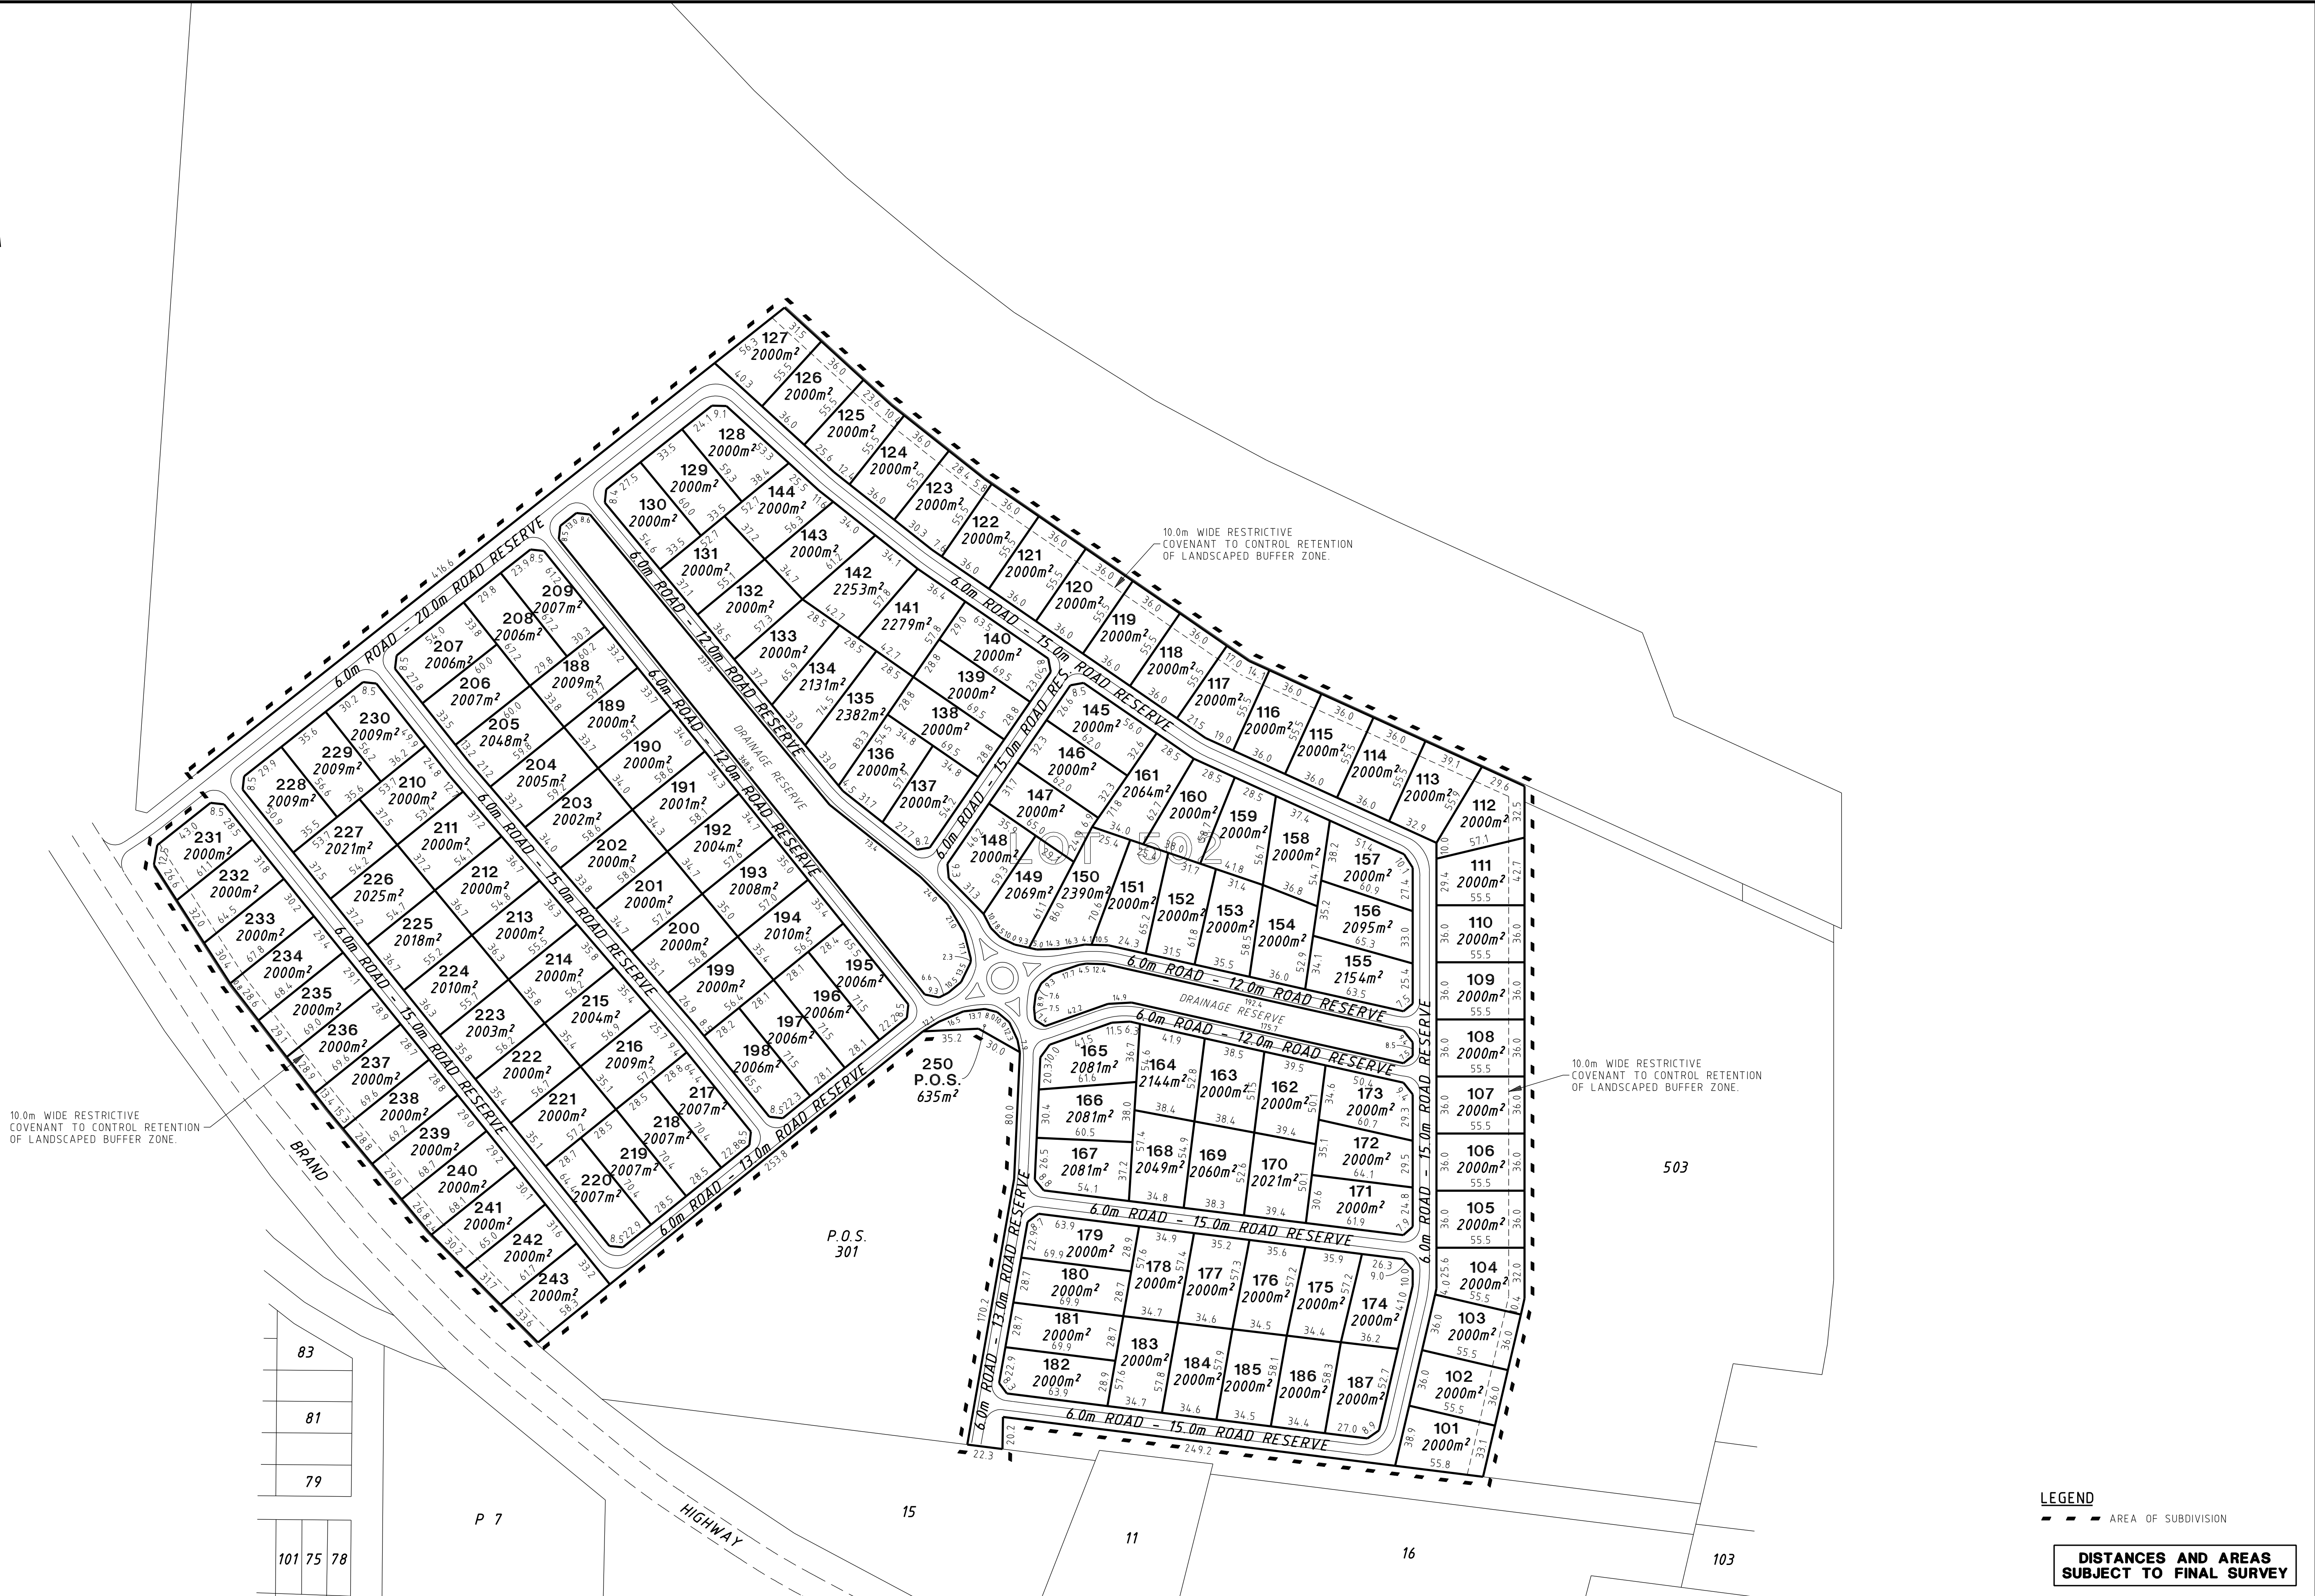
**APPENDIX B**  
**PROPOSED SUBDIVISION PLAN**

10.0m WIDE RESTRICTIVE COVENANT TO CONTROL RETENTION OF LANDSCAPED BUFFER ZONE.

DISTANCES AND AREAS SUBJECT TO FINAL SURVEY

On 10 March 2006, Lot 502 was approved for subdivision by the WA Planning Commission ("WAPC") reference 129561 into 143 residential lots of about 2000m<sup>2</sup> in area each ("Approval 129561"). The plan of the proposed subdivision of Lot 502 is included herein as Appendix B.
